**Subject: Nashville International Airport Gas Line
Nashville, Davidson County, Tennessee
Contract Number (No.) EP-S4-14-03
TDD No. TT-03-034**

The Tetra Tech, Inc. (Tetra Tech) Superfund Technical Assessment and Response Team (START) submits this letter report summarizing emergency response activities conducted April 9 through 19, 2019, at the Nashville International Airport Gas Line release site (Site) in Nashville, Davidson County, Tennessee. This report includes three enclosures:

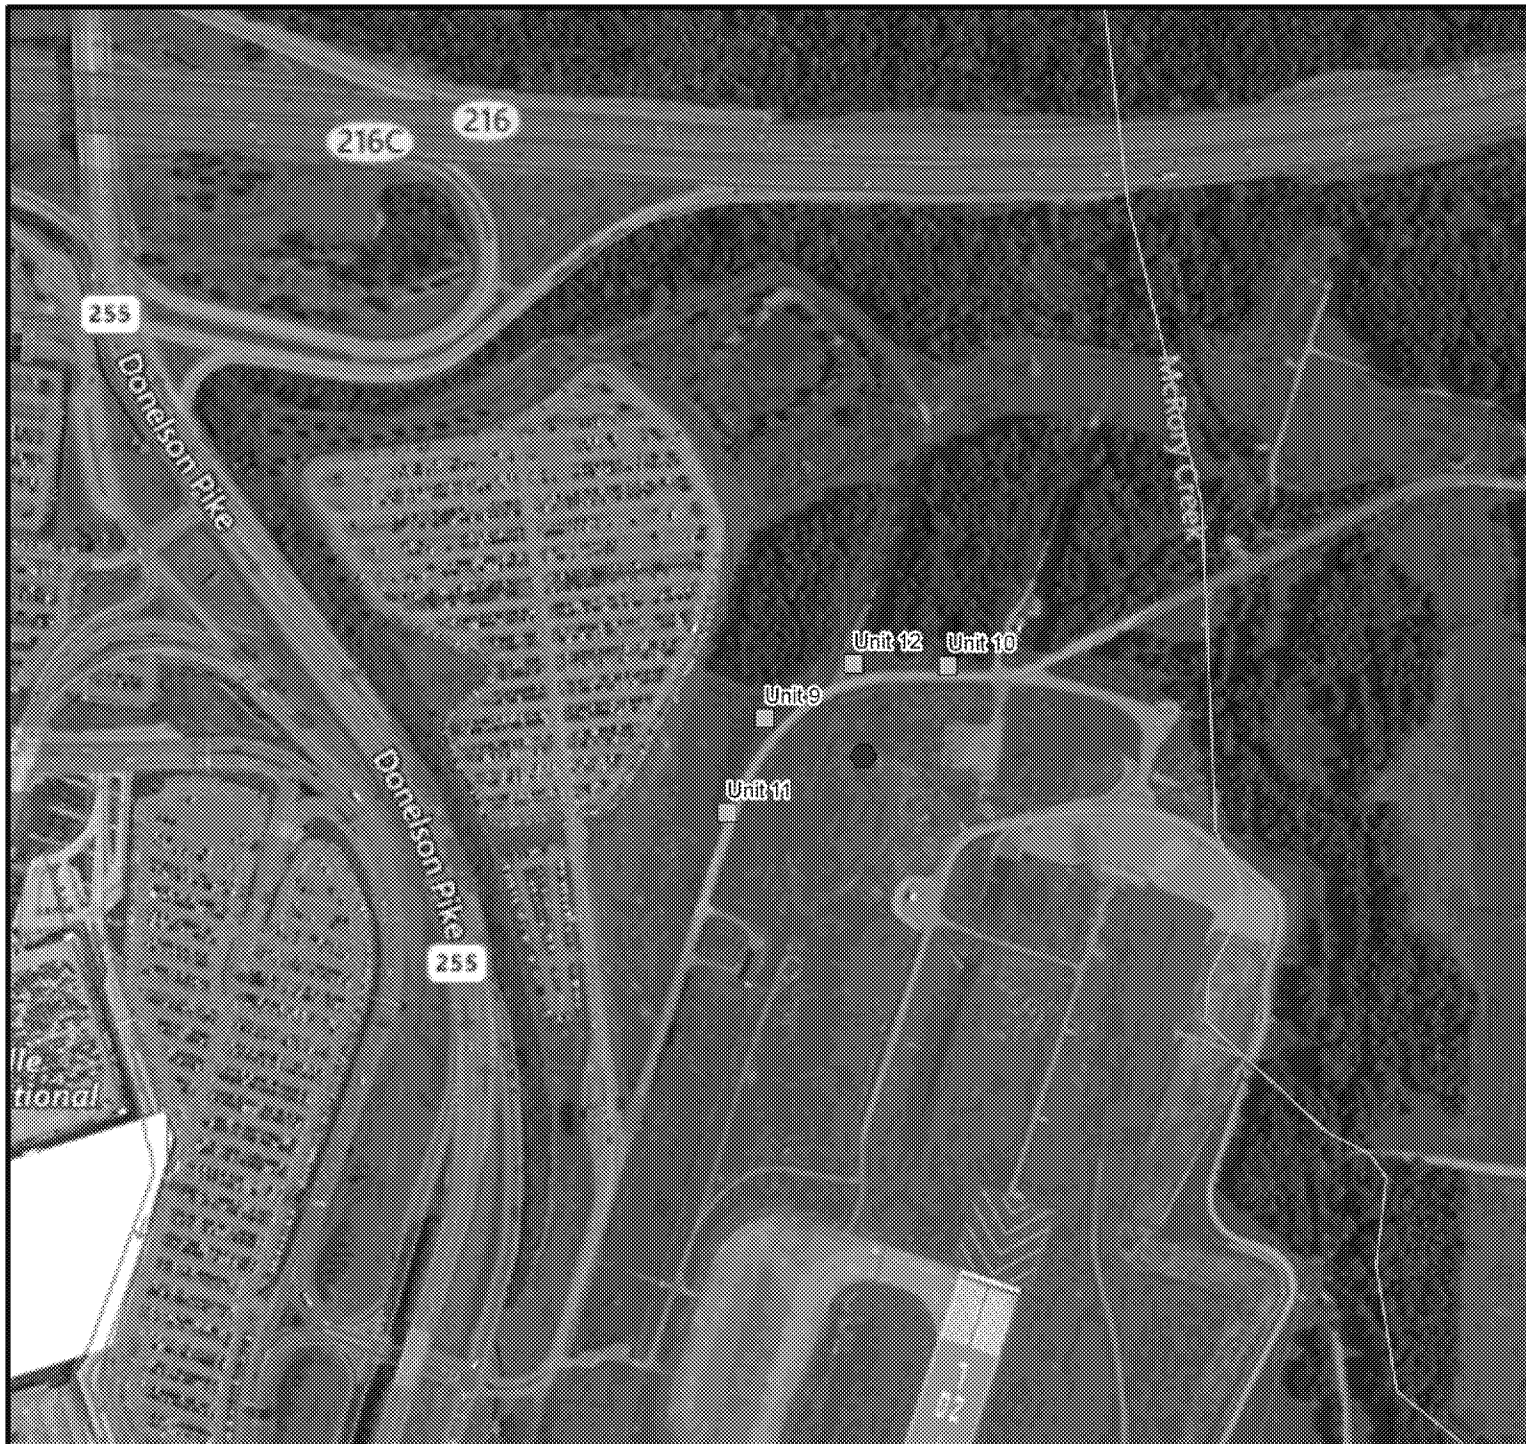
FIGURE 2

On April 10, Tetra Tech START set up an AreaRae Pro air monitoring station between the site and the public parking lot to the west (see Figure 2 in Enclosure 1, Unit 9). The AreaRae Pro was configured with sensors for detection of oxygen, carbon monoxide, hydrogen sulfide, lower explosive limit (LEL), volatile organic compounds (VOCs), and gamma radiation. Tetra Tech START monitored the station from the site staging area via a computer using ProRae Guardian and VIPER telemetry. Due to VOC readings that ranged from 3 to 13 parts per million (ppm), three additional air monitoring stations were set up (see Figure 2 in Enclosure 1). All four stations sampled continuously until the evening of April 11.

Air Monitoring Locations
